#### 1 - 2 Project Spotlight: Woodsyde

# Project Spotlight: Woodsyde Stormwater and Stream Restoration By Elizabeth Spencer, Watershed Restoration Engineer

### **Testing Innovative Ways to Remove Phosphorus from Stormwater**

#### Runoff By Byron Madigan, Water Resource Supervisor

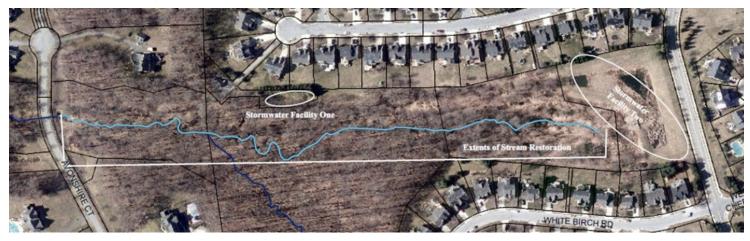
after 🎊

before 🎊

Century Engineering was contracted for the stormwater retrofit and stream design. The County received \$50,000 from the National Fish and Wildlife Foundation to help fund project design. The stream design approach was to raise the stream as much as possible while providing a sustainable stream and floodplain system and forest impacts minimizing of construction. The majority of the stream bed was raised by 5-6 vertical feet, with the channel meandering mostly within the original channel The nested floodplain footprint. terrace was designed to convey the majority of the 50-year storm event.

The restored channel has low banks to allow the rooting system of floodplain vegetation to extend into the nutrient rich hyporheic zone. Grade control log structures, cut-off sills, and clay channel plugs were also designed to raise the groundwater table for floodplain reconnection and nutrient processing. The new plantings will complete the construction phase for Magstone Construction; however, the larger rewards will be visible as the stream and floodplain system settles and becomes more established over the next two to three years. The County received a grant award from the Maryland Department of the Environment Bay Restoration Fund towards construction of this project.
